DTNSRDC-84/009

**RUBBER TO BACKING BOND STRENGTH  
FOR STAVE BEARINGS**

**SHIP MATERIALS ENGINEERING DEPARTMENT  
RESEARCH AND DEVELOPMENT REPORT**

April 1984

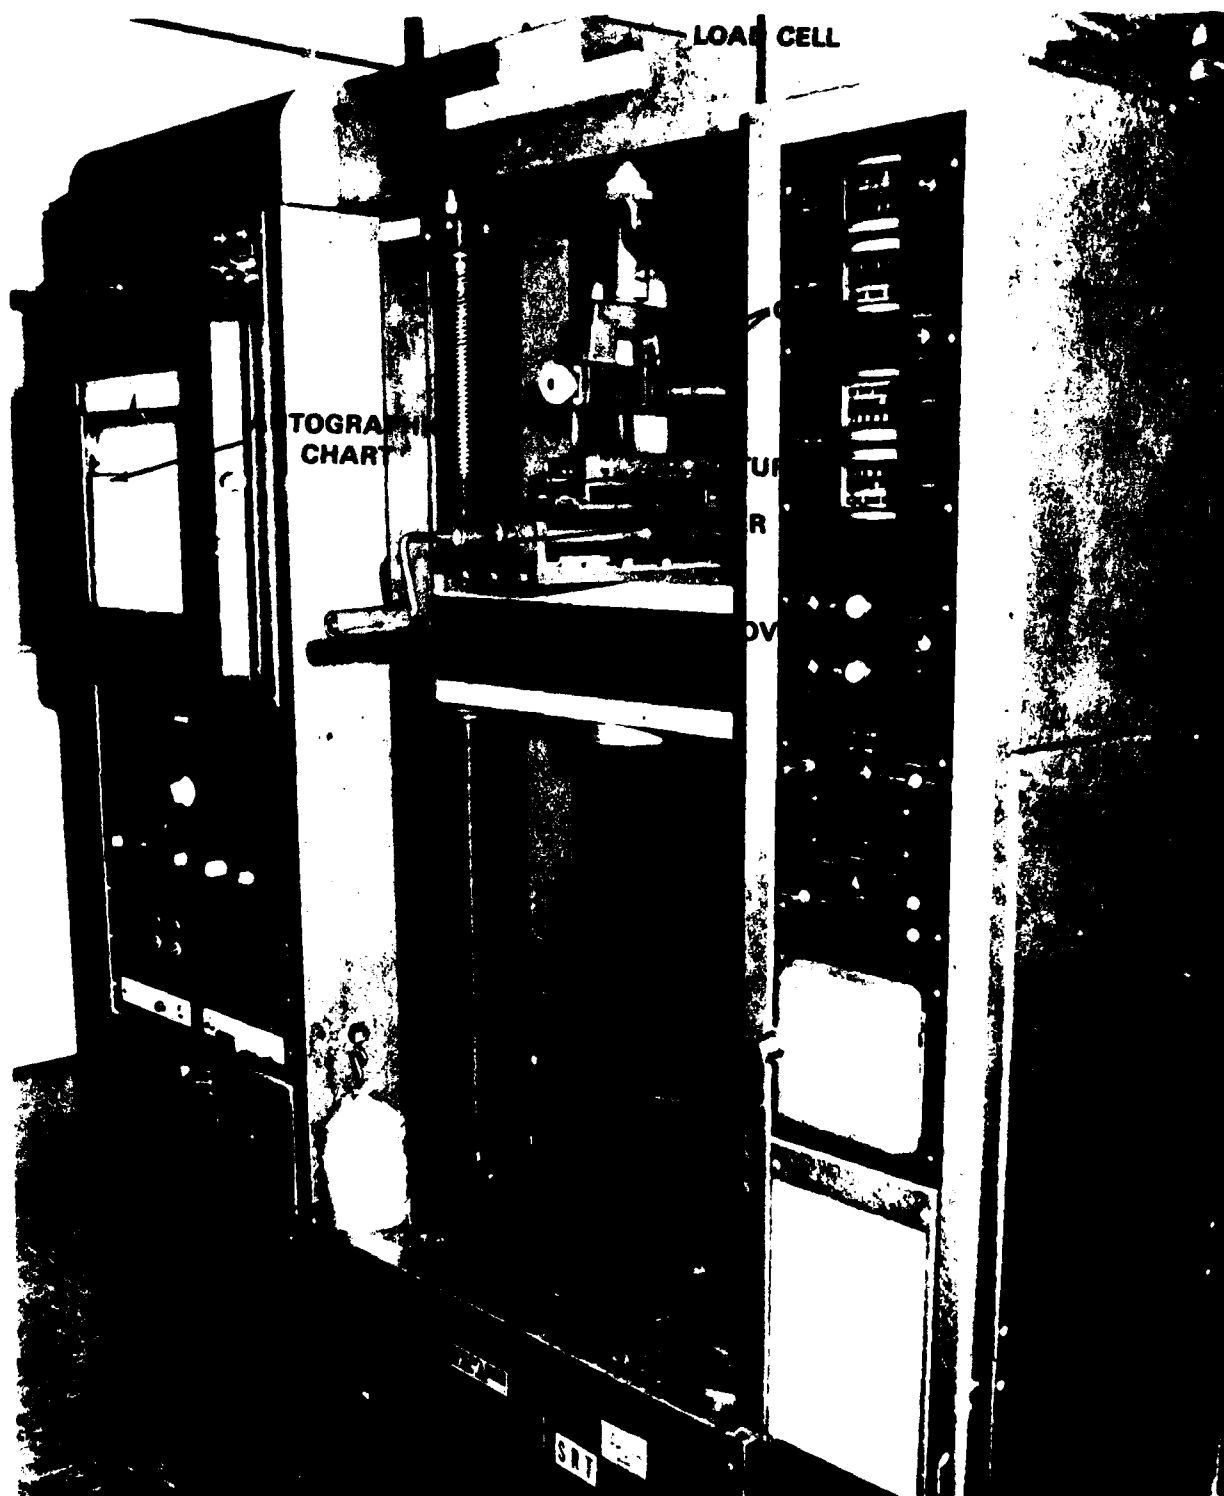
Figure 5 - Right Angle Pull Test Machine

Carrier provides  $90^\circ$  pull angle as the strip is removed. Unit is mechanically controlled; the carrier crank is used by the machine operator to adjust the angle as the strip is removed (Figure 6).

Autographic chart prints out continuous trace of the magnitude of force needed (as sensed by the load cell) to pull the test strip from the backing.
